EPA Region 10 Dive Team

Onondaga Vessel Survey, Seattle, WA

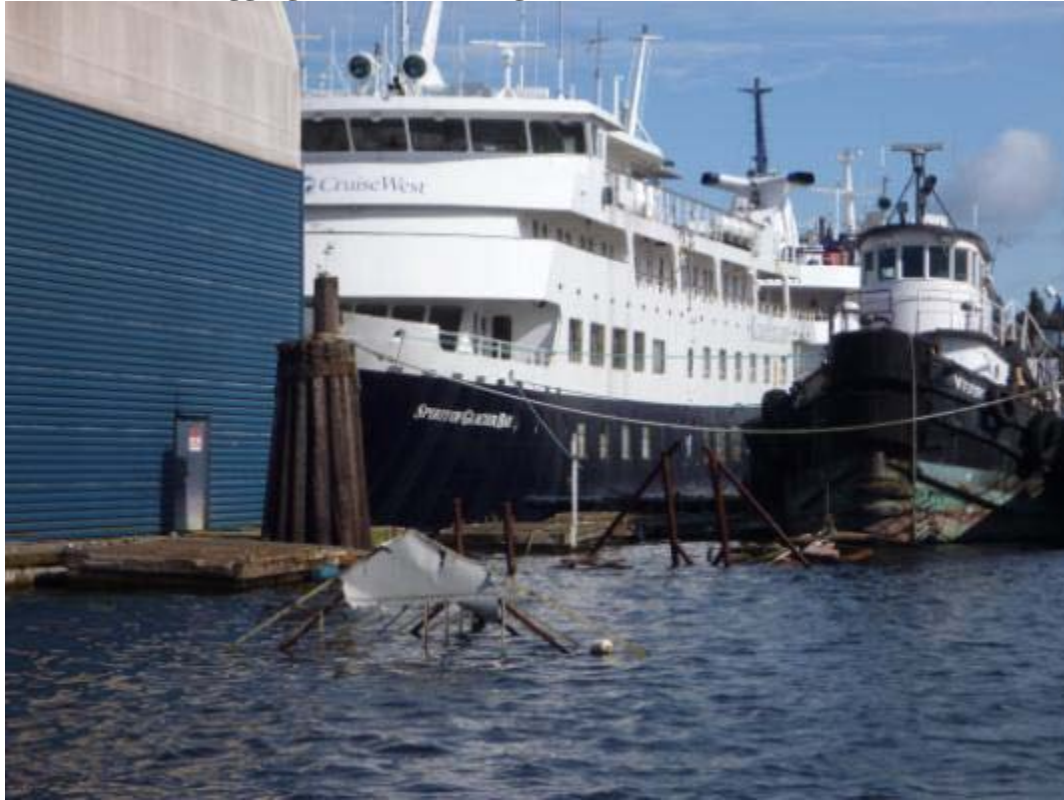
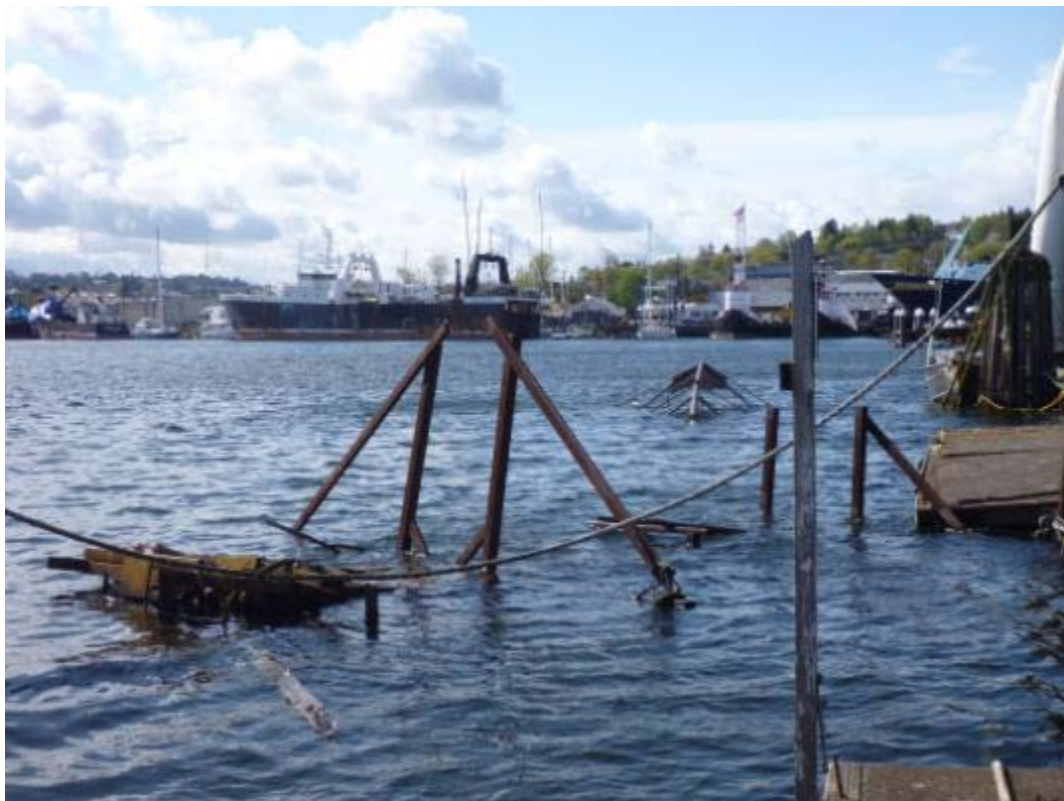
Above surface rigging on the Onondaga.

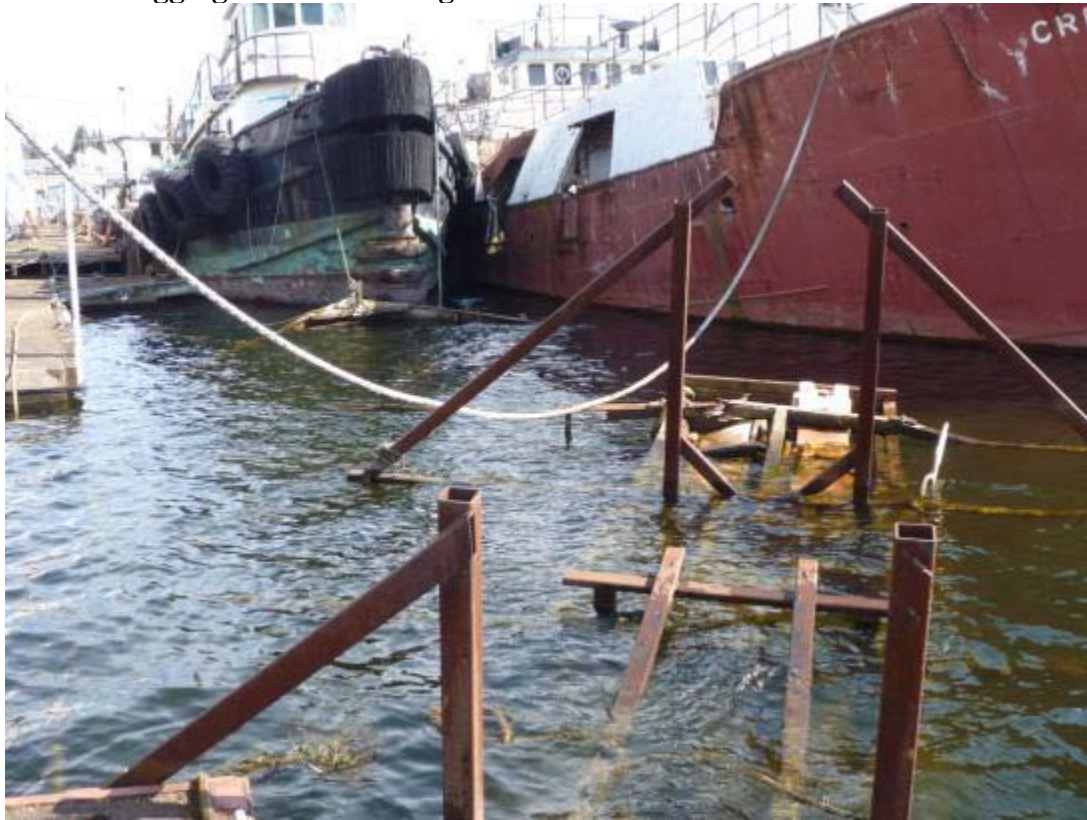
Forward rigging on the Onondaga.

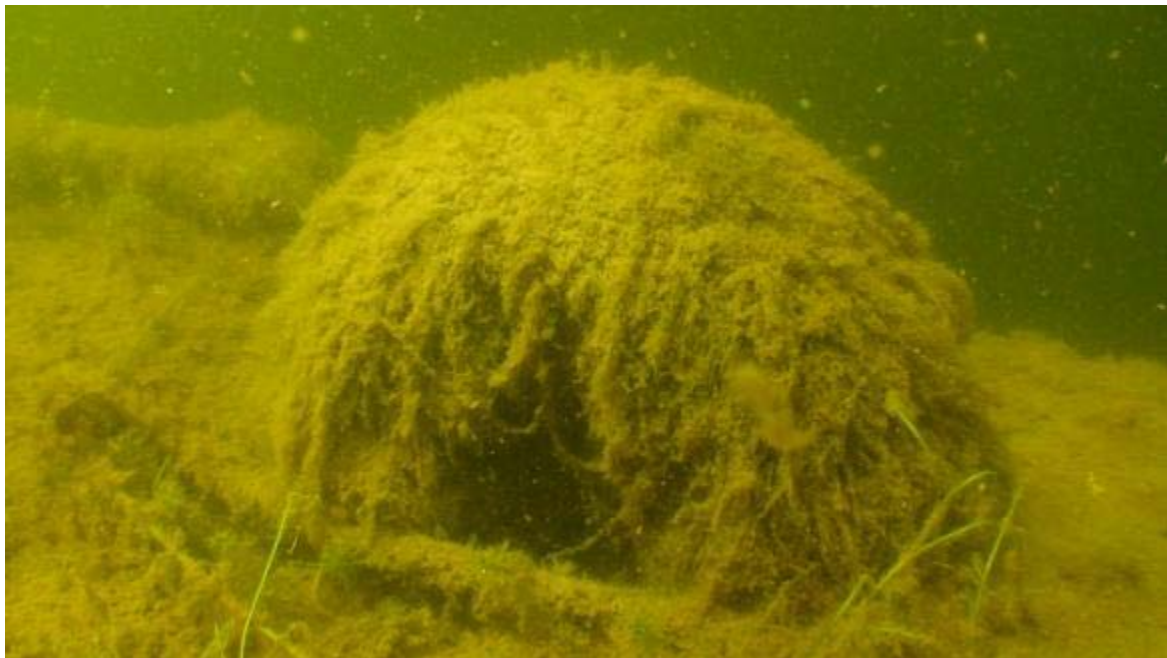
Metal tie down on forward deck.

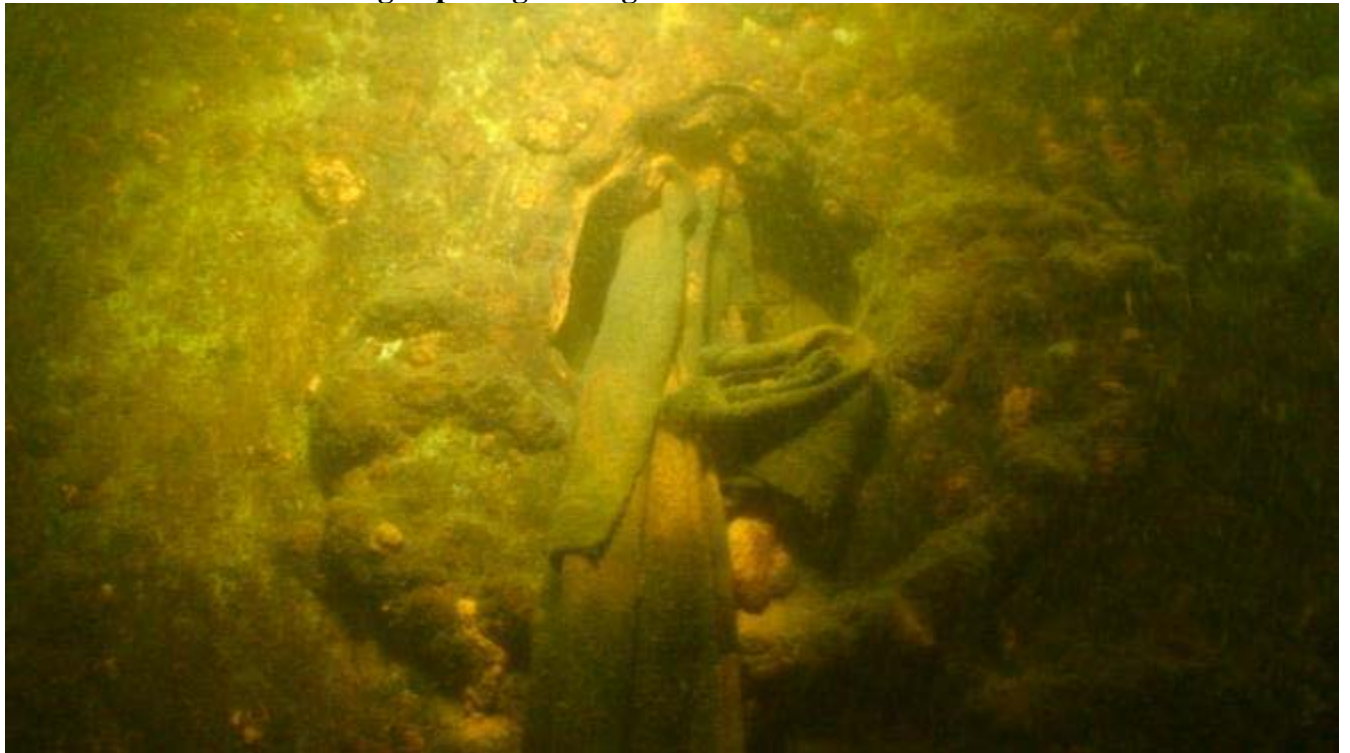
Old line and material through opening in the gunnel.

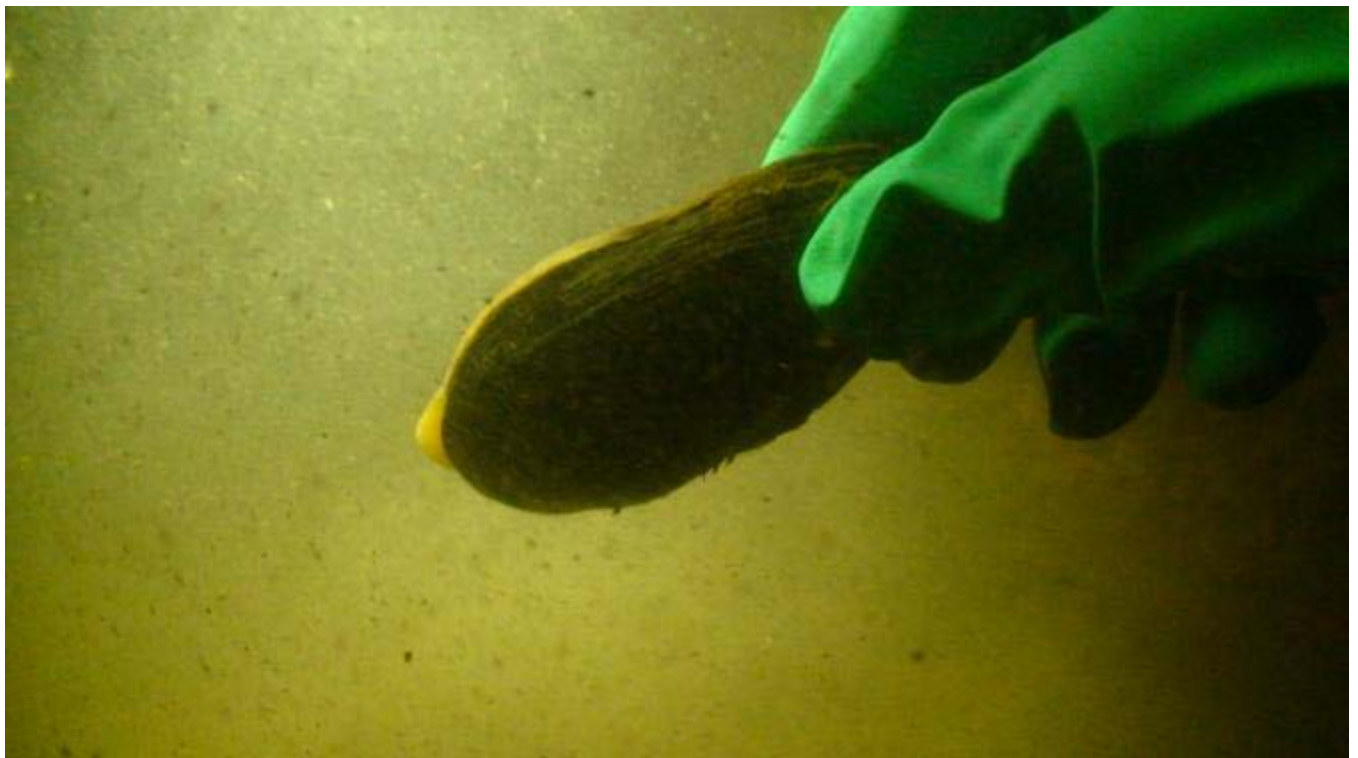
Freshwater mussel.
